SITE INVESTIGATION
SAMPLE STRATEGY PLAN
SITE 10
ORIGINAL BASE LANDFILL

MARINE CORPS BASE
CAMP LEJEUNE, NORTH CAROLINA

CONTRACT TASK ORDER 0369

SEPTEMBER 30, 1996

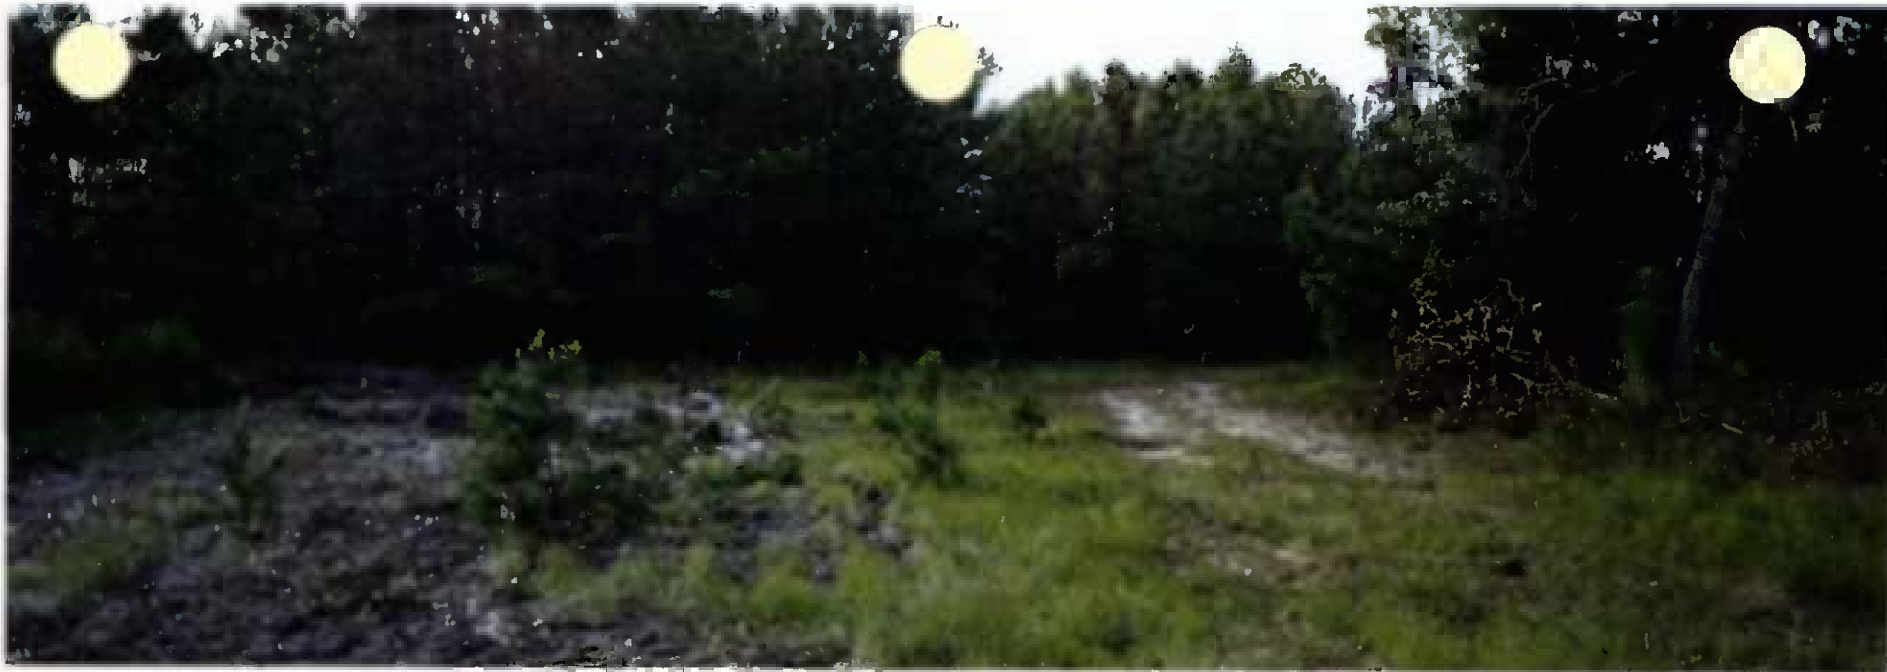
- The suspected location of the site is approximately 150 feet west of Holcomb Boulevard in an area which contains few trees and heavy underbrush. The trees that do exist in the area appear to be less than 10 years in age.

Photograph 1-1: Photograph of a portion of the “cleared area”. Note the treeline in the background which indicates the beginning of the wooded area surrounding the suspected site location.

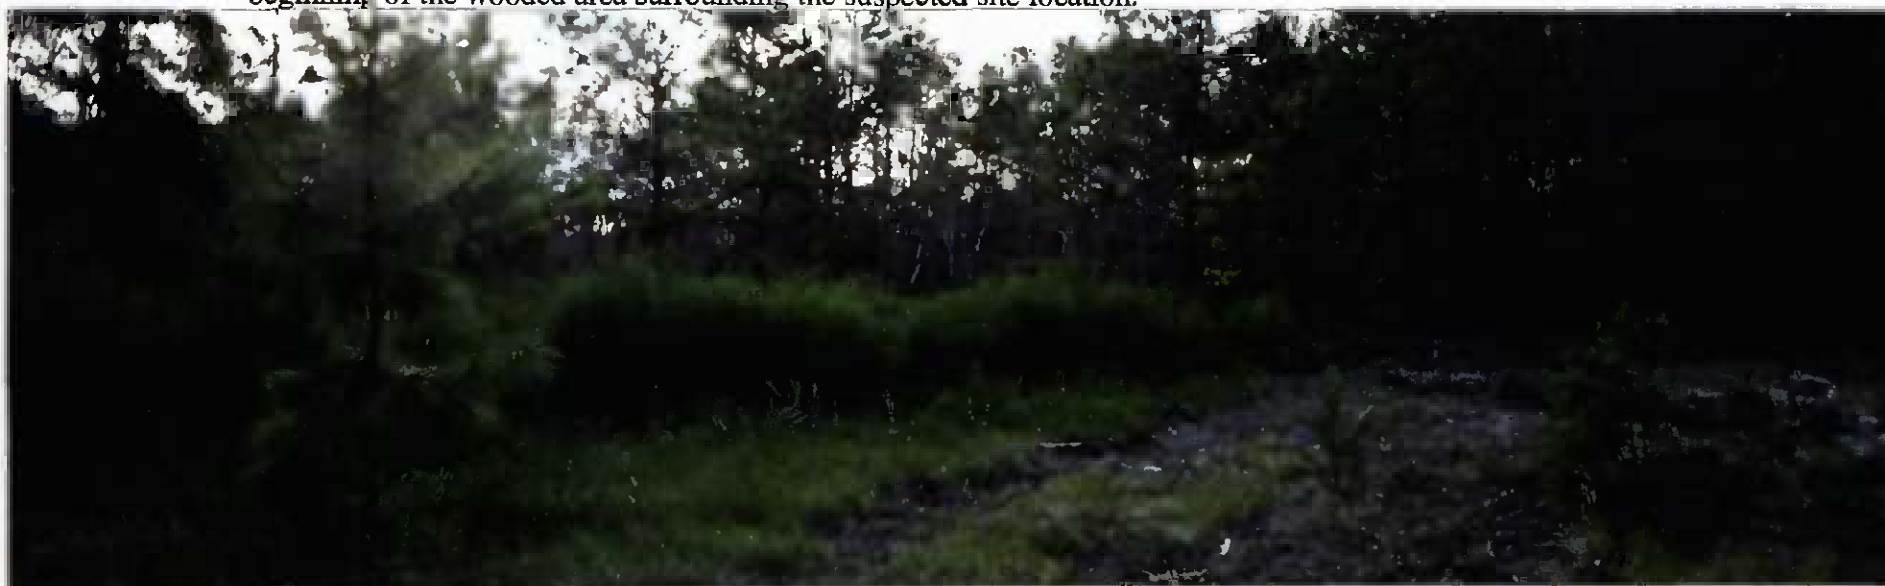
Photograph 1-2: Photograph illustrating the thick underbrush present in the southern portion of the “cleared area”.

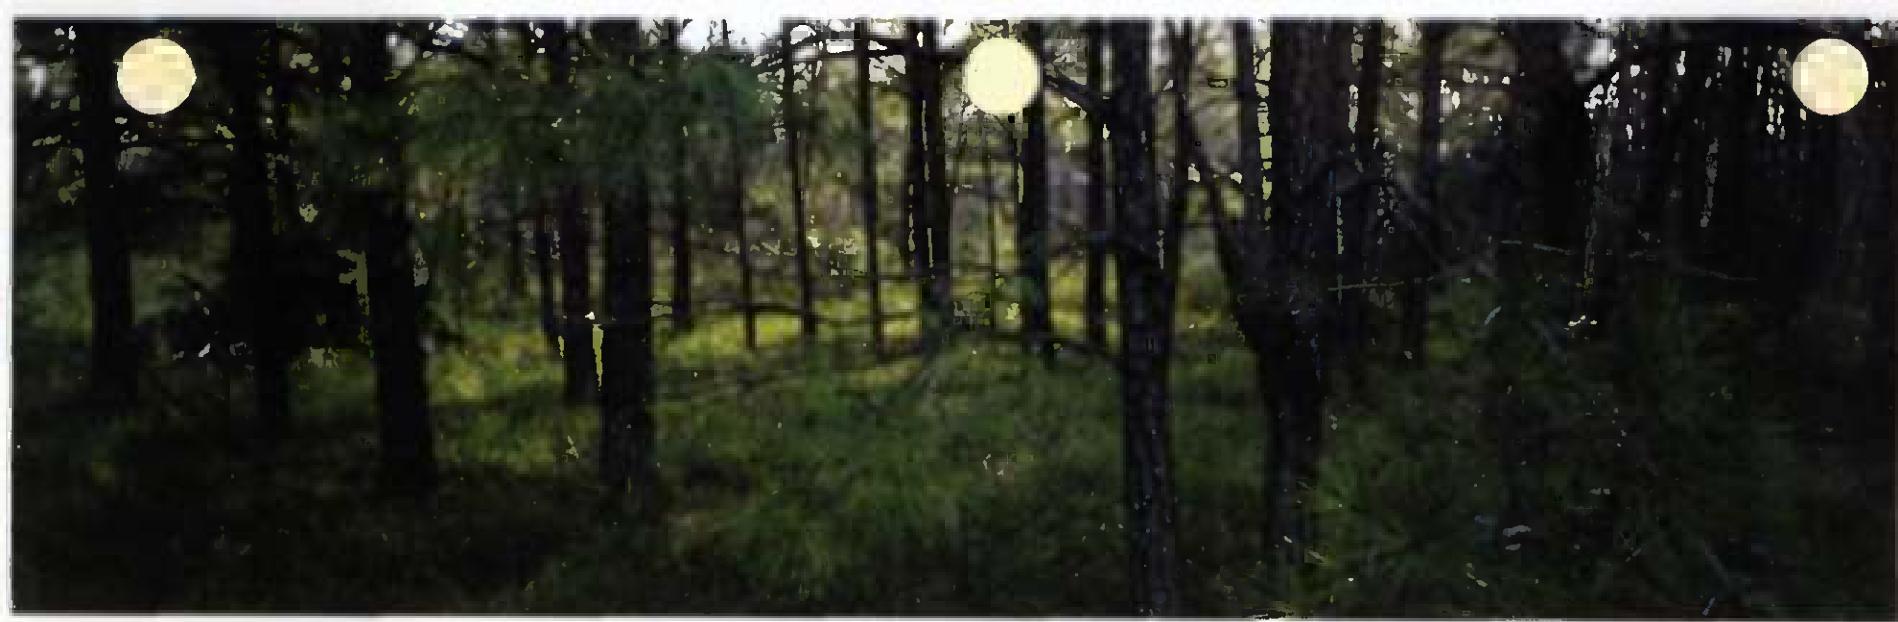
Photograph 1-3: This photograph depicts the density of the wooded area. As one can see, there are areas where the trees are younger or not present.

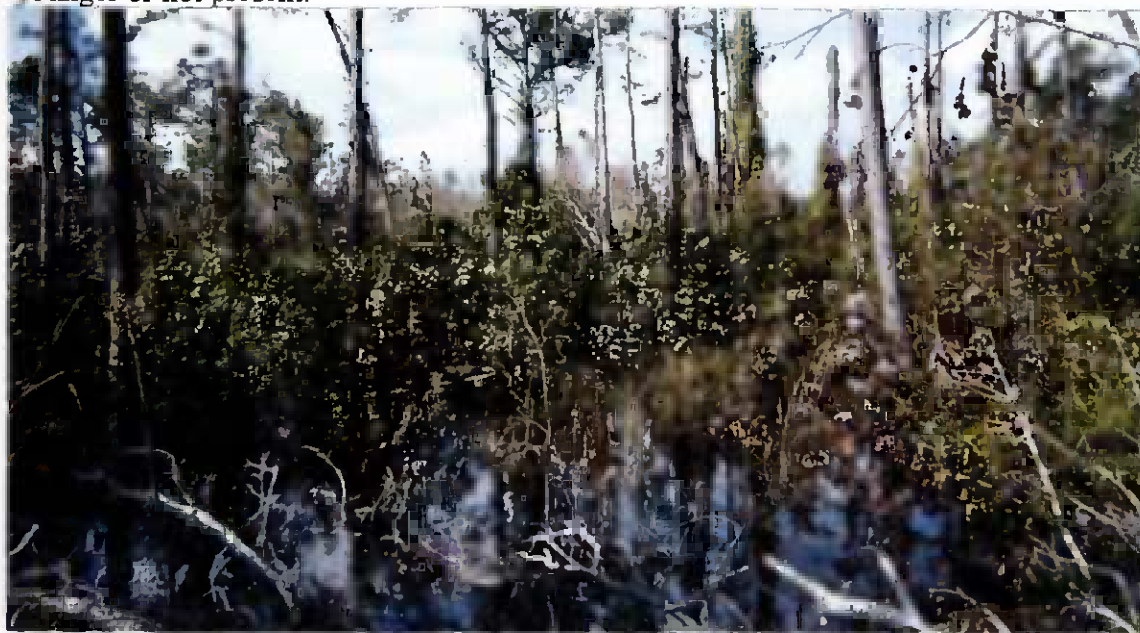
- The surrounding area is wooded with trees varying in age from saplings to 30 - 40 years in age. Many swamps exist south, west and north of the suspected site location. It is not certain if the swamps presently exist due to the recent amount of rain, or if these areas remain marsh during most of the year.

Photograph 1-4: Photograph depicting one of the marshy areas surrounding the site. This particular marsh area exists south of the suspected location of the landfill.
