FINAL

FIVE-YEAR REVIEW

MARINE CORPS BASE, CAMP LEJEUNE, NORTH CAROLINA

CONTRACT TASK ORDER 0099

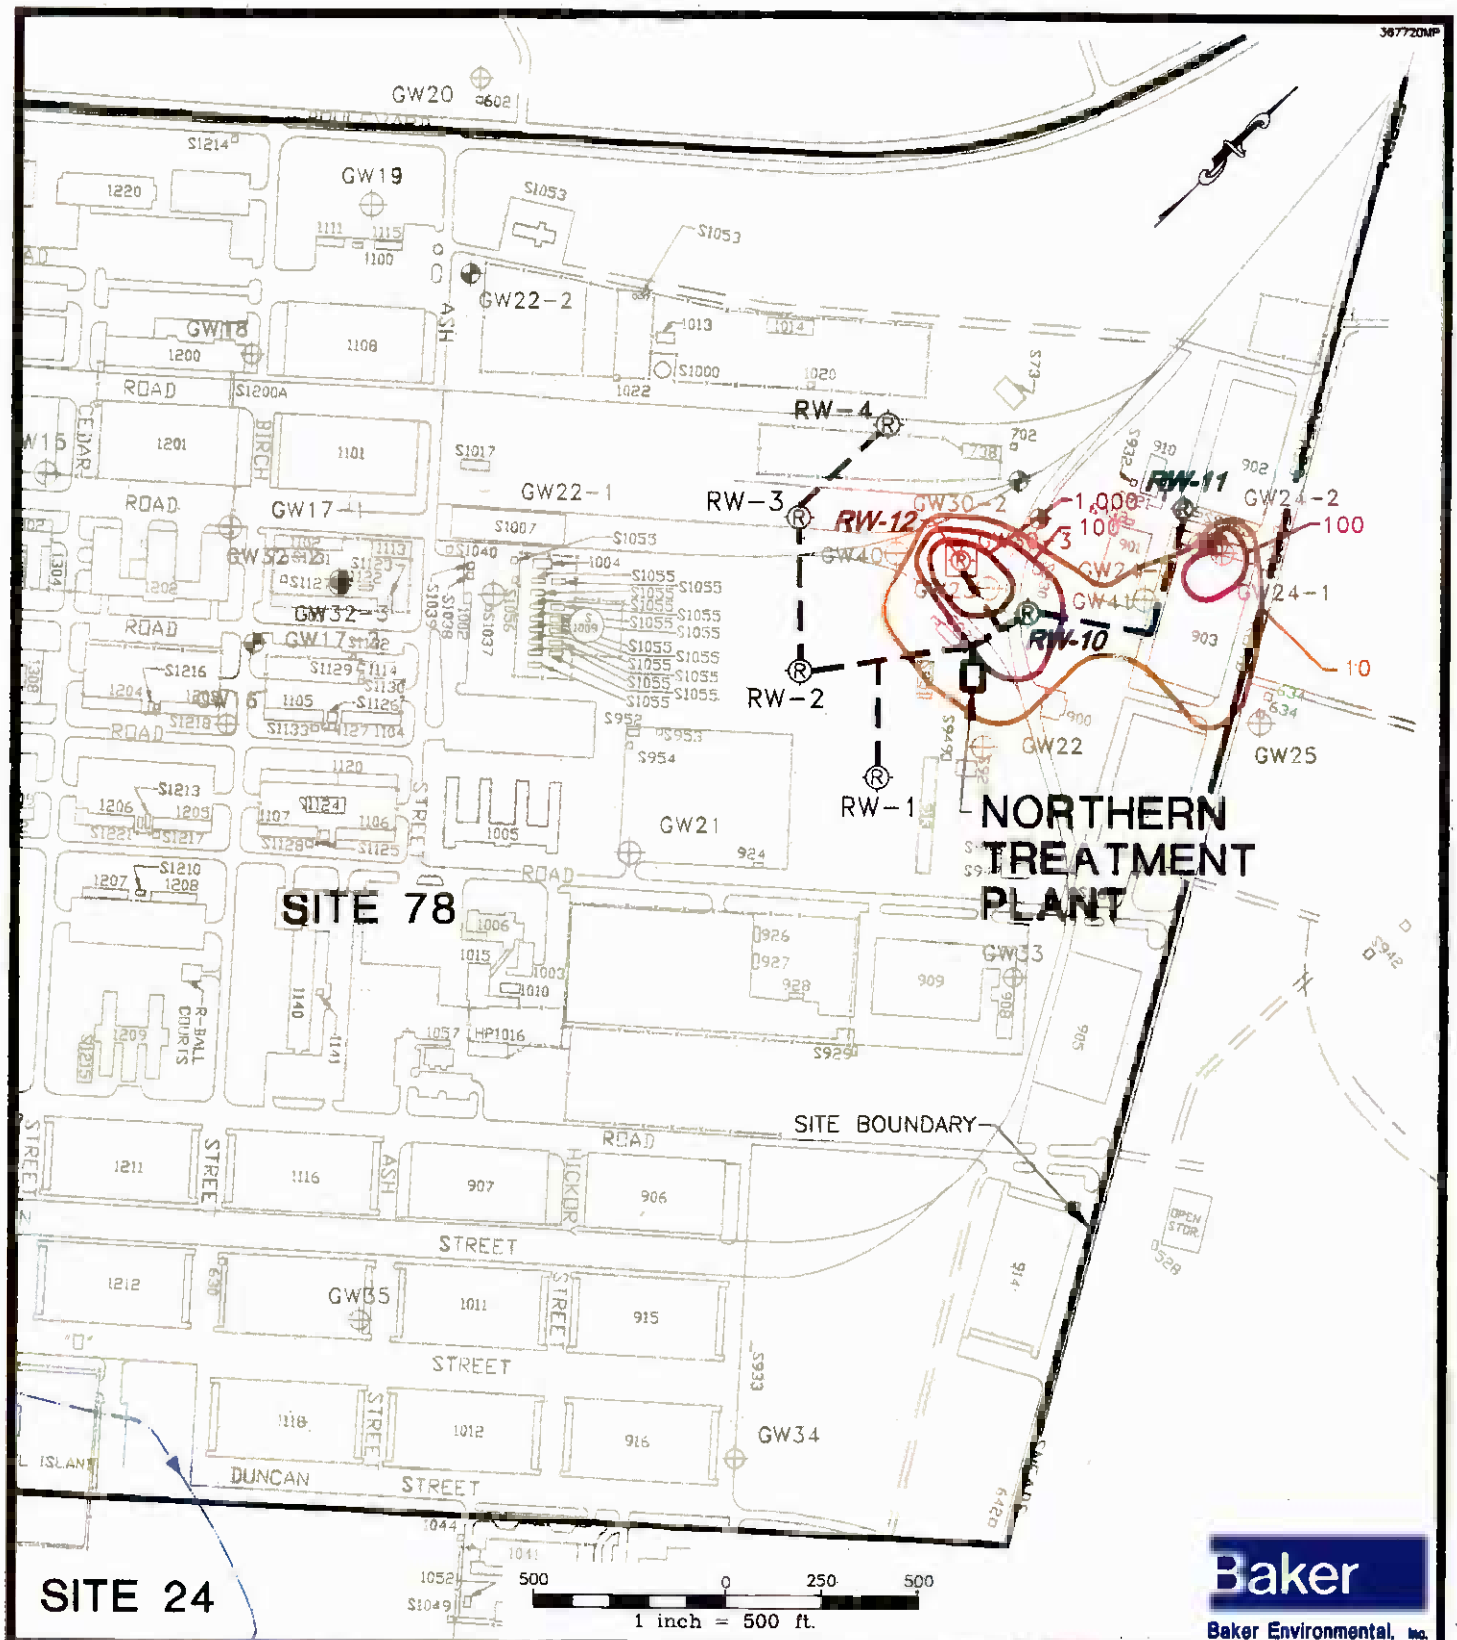
FIGURE 2-1

Two separate phases of upgrades to the groundwater extraction and treatment systems at Site 78 have been initiated during the past four years. Figures 2-1 and 2-2 depict the northern and southern treatment systems at Site 78. Three groundwater extraction wells were added to the southern treatment system during the most recent upgrade phase. One extraction well was also added to the northern treatment system and two other existing extraction wells were refurbished. The upgrades were the result of supplemental data evaluations performed during the RI/FS and groundwater monitoring program. In addition, recent alterations to the monitoring program have resulted in a more accurate depiction of true groundwater conditions. Because the groundwater extraction and treatment systems at Site 78 undergo periodic evaluation, the protectiveness of the systems is ensured. If any additions or changes to the systems are necessary, they will be incorporated into the current O&M program.

NORTHERN TREATMENT PLANT-SITE 78
FIVE-YEAR REVIEW, CTO-0099
MARINE CORPS BASE, CAMP LEJEUNE
NORTH CAROLINA

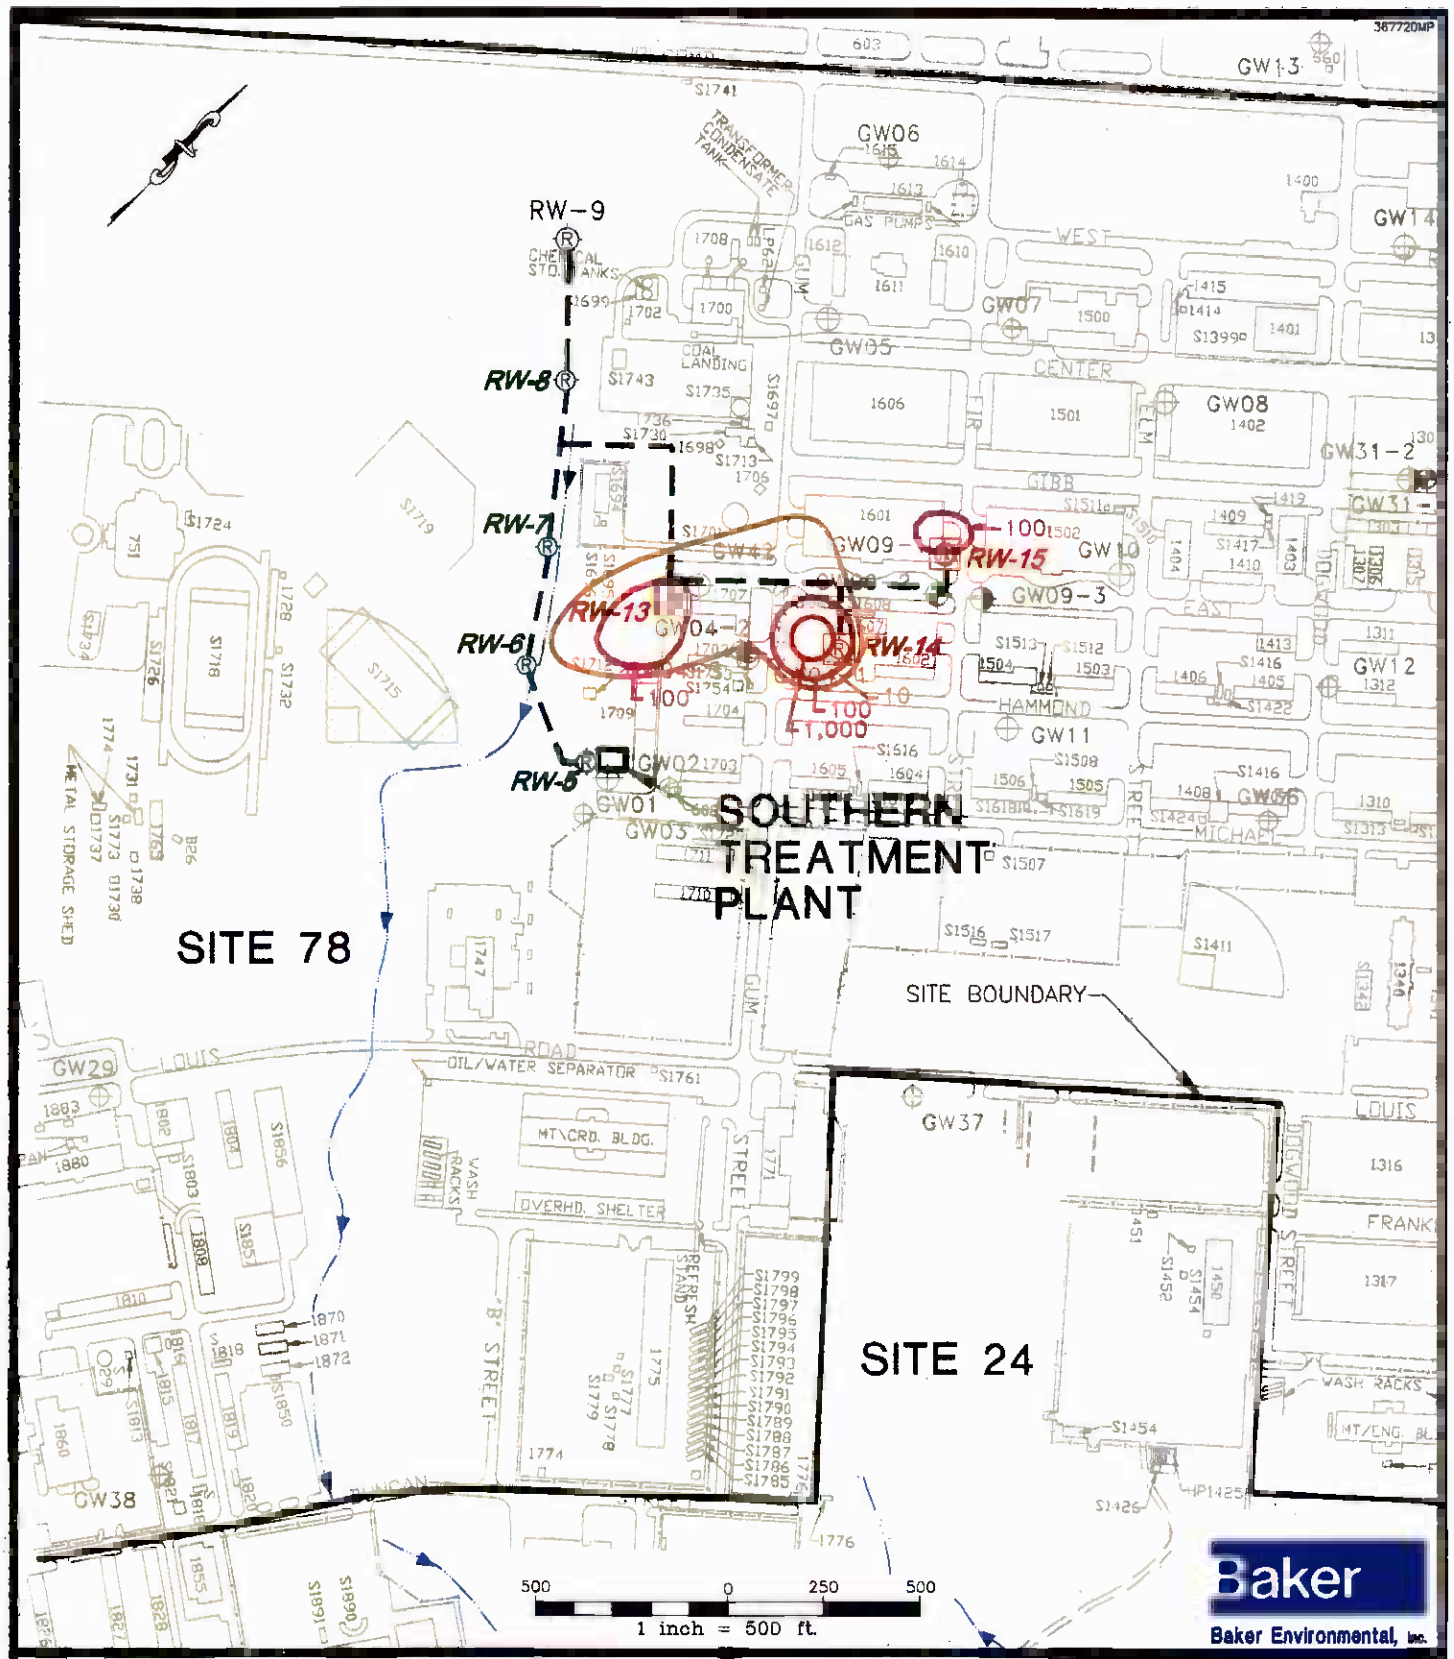
FIGURE 2-2

SOUTHERN TREATMENT PLANT-SITE 78
FIVE-YEAR REVIEW, CTO-0099
MARINE CORPS BASE, CAMP LEJEUNE
NORTH CAROLINA

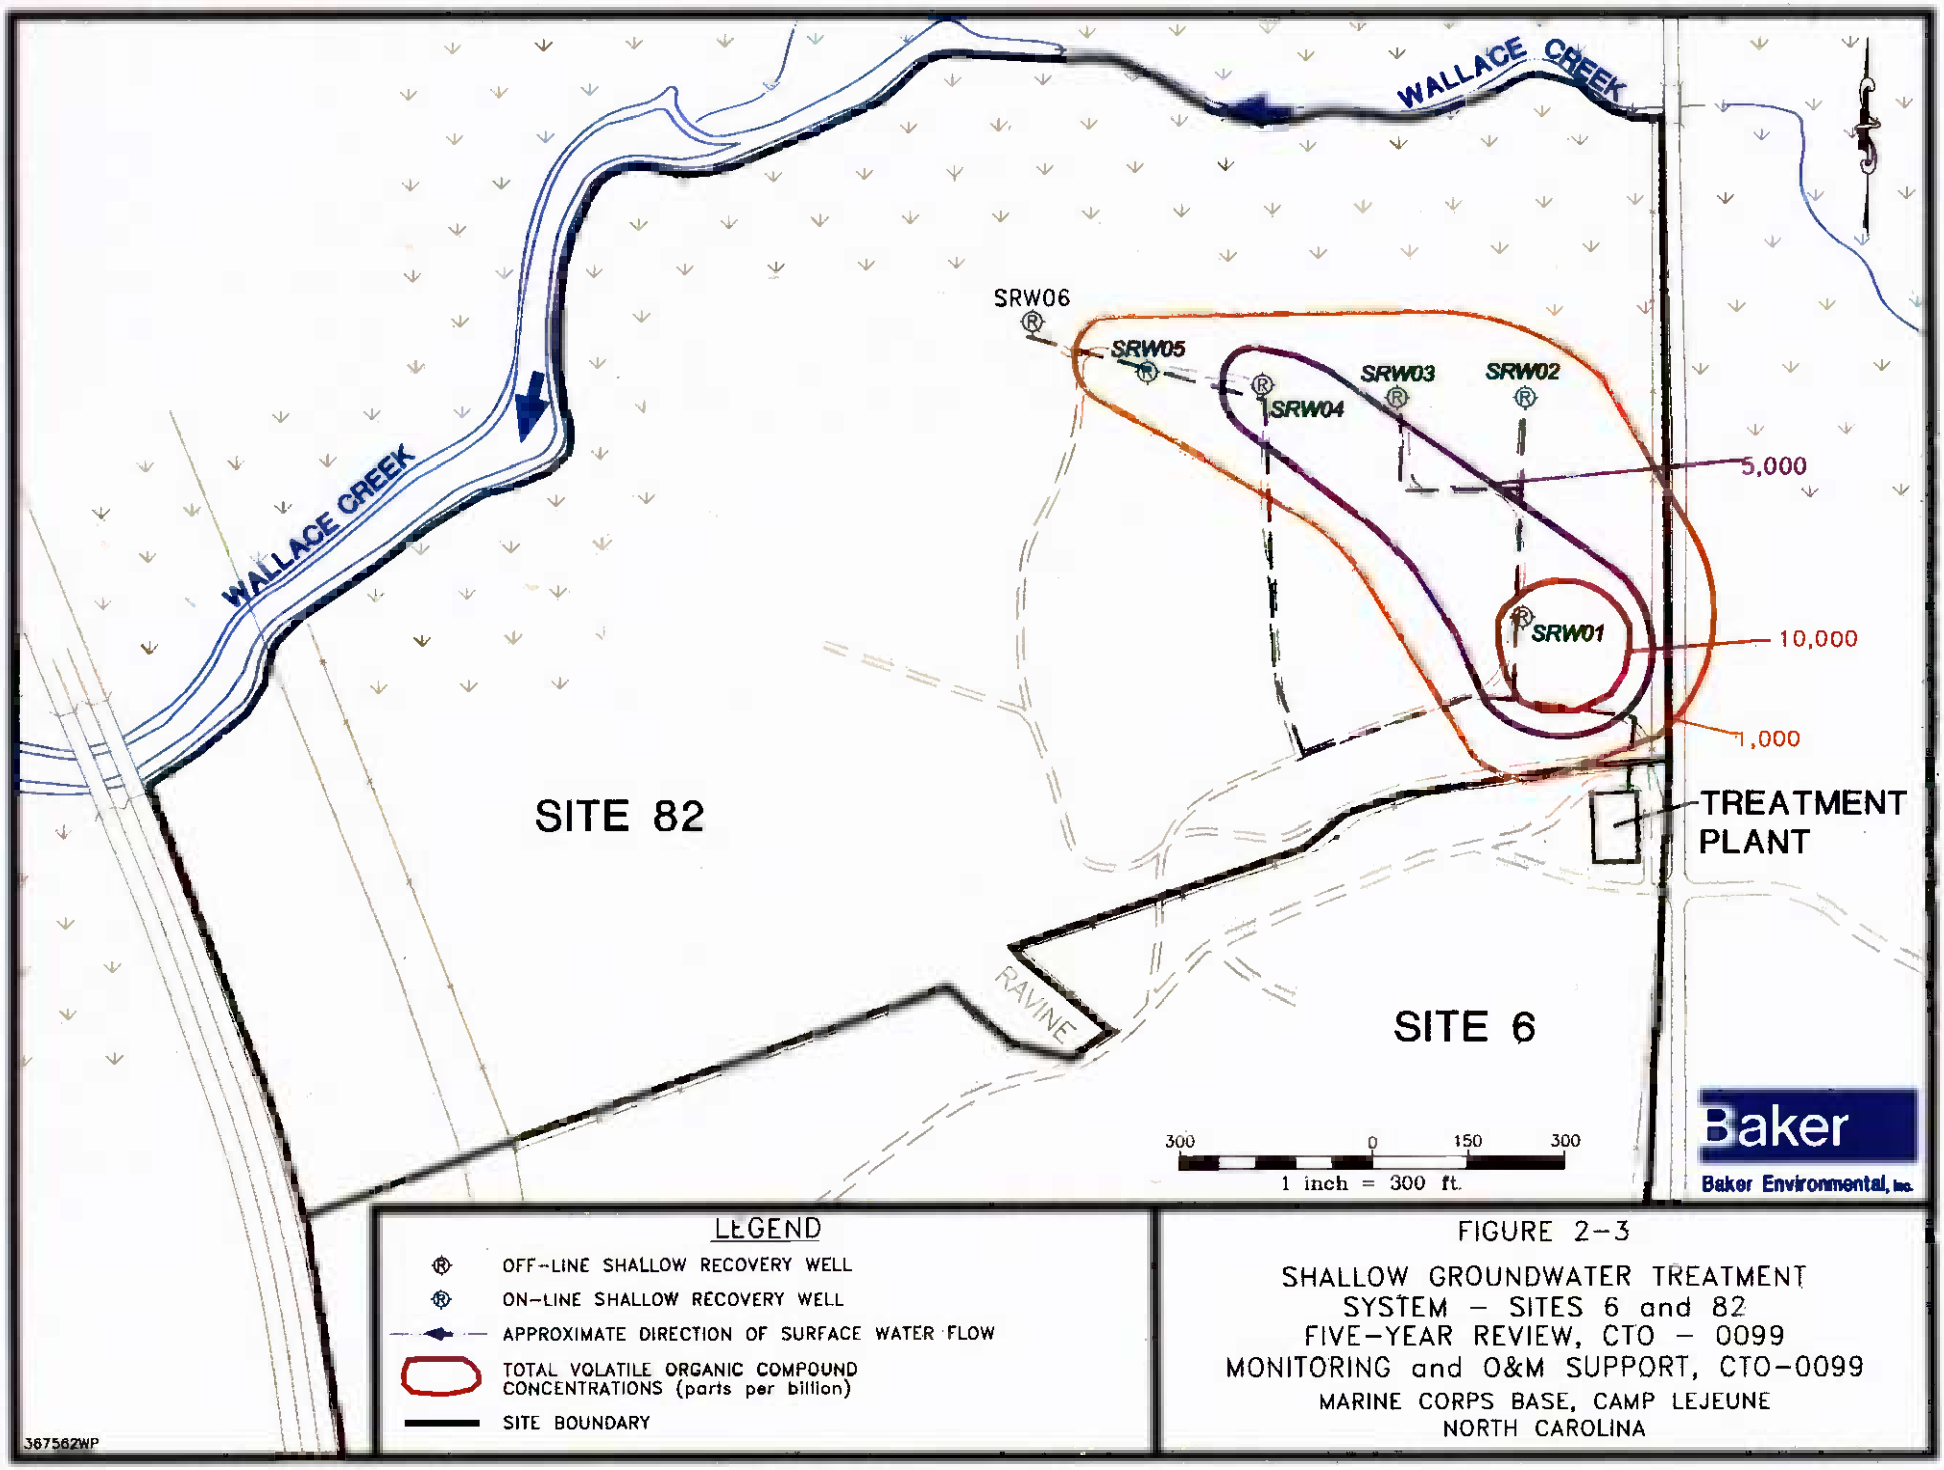
FIGURE 2-3

Figures 2-3 and 2-4 depict the shallow and deep groundwater extraction systems at Site 82. Because the groundwater extraction and treatment systems at Site 82 undergo periodic evaluation, the protectiveness of the systems is ensured. If any additions or changes to the systems are necessary, they will be incorporated into the current O&M program.

SHALLOW GROUNDWATER TREATMENT SYSTEM – SITES 6 and 82
FIVE-YEAR REVIEW, CTO – 0099
MONITORING and O&M SUPPORT, CTO-0099
MARINE CORPS BASE, CAMP LEJEUNE
NORTH CAROLINA

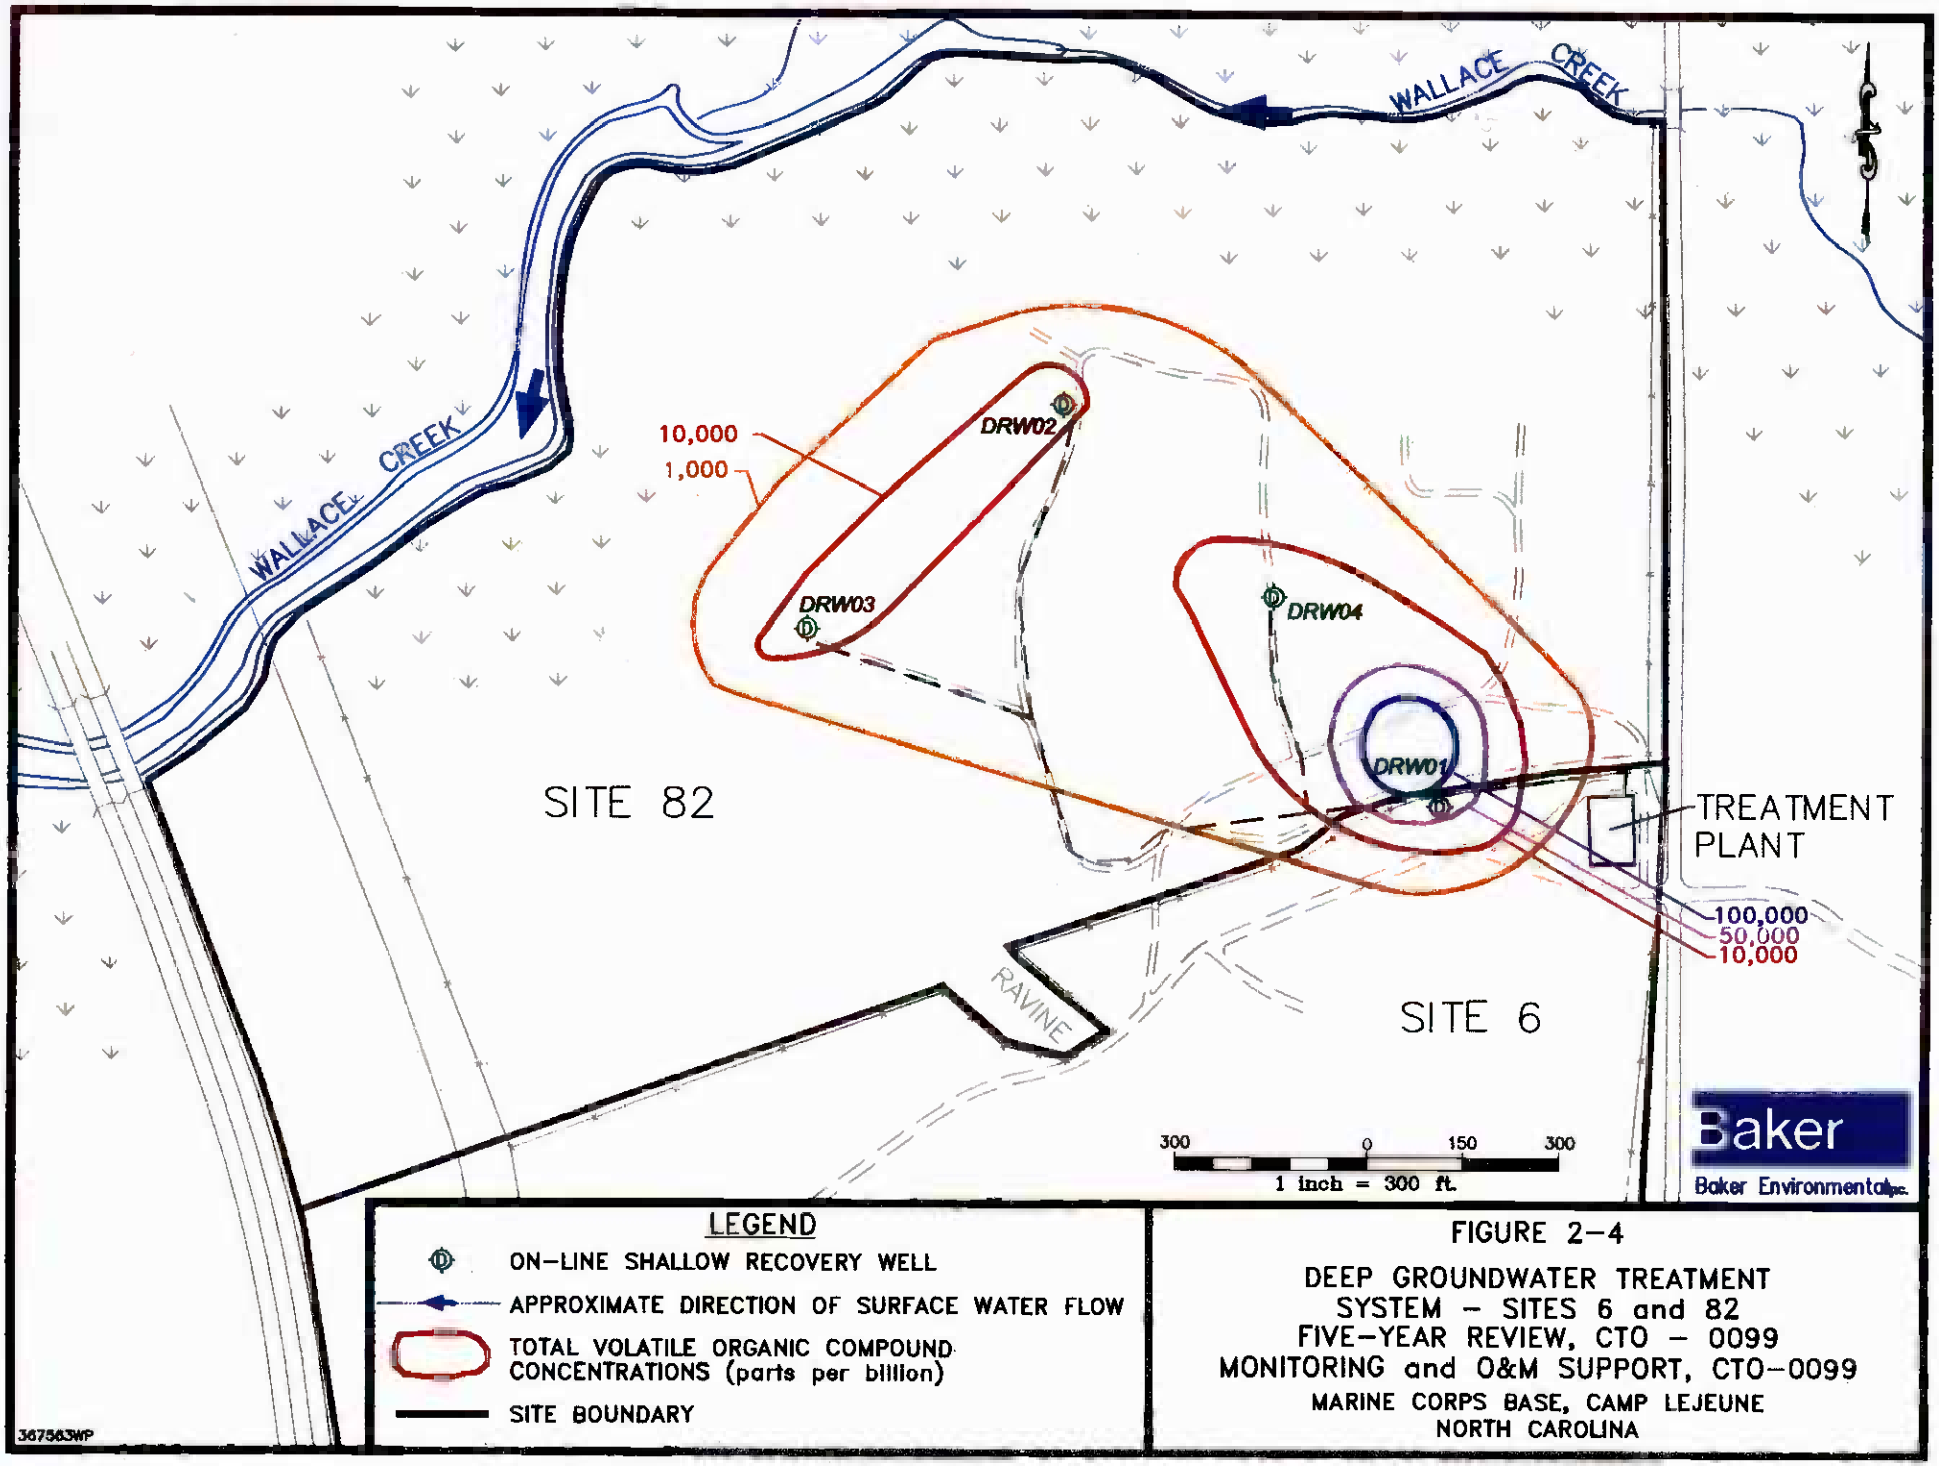
FIGURE 2-4

DEEP GROUNDWATER TREATMENT SYSTEM - SITES 6 and 82
FIVE-YEAR REVIEW, CTO - 0099
MONITORING and O&M SUPPORT, CTO-0099
MARINE CORPS BASE, CAMP LEJEUNE
NORTH CAROLINA

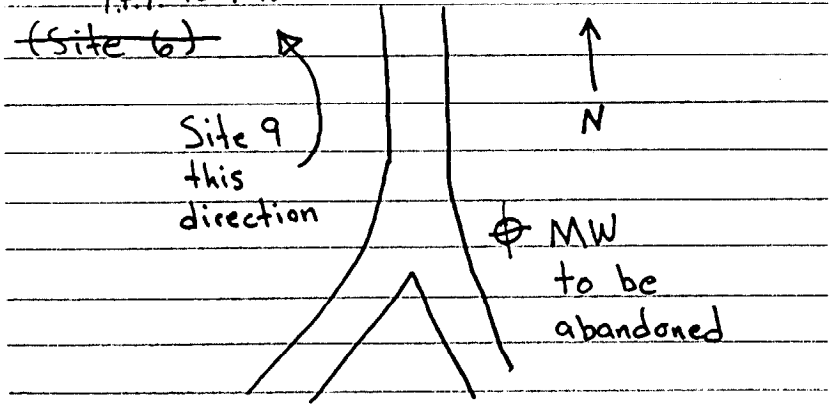
(Site 6) Site 6 is now used as a wood recycling / composting area in addition to its original use. Bldg. 601 (grease trap) has been added. Also added a storm water retention pond and large storage lot between Lots 201 and 203. Correction, 100'x250' stormwater pond, large raised area with gravel. 06-GW18 may be abandoned. Raised area adjacent to lot 201 to the east. Construction south of the raised area taking place at time of visit. New base landfill across Piney Green from Site 6 to east. Raised area is 10' above grade 200'x 400', protected by six foot fence. 06-GW06 may be abandoned also. 06-GW17 will be abandoned during construction project. Many of the wells on the southern portion of the site may be abandoned. Site is mixed-use now

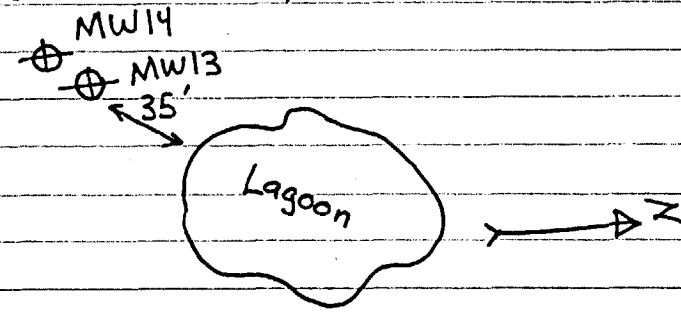
(Site 84 continued)

MW14 installed Dec. 91
Screen 17 to 27' bgs
Sand 15 to 27' bgs
2" diameter
Bentonite 13 to 15' bgs

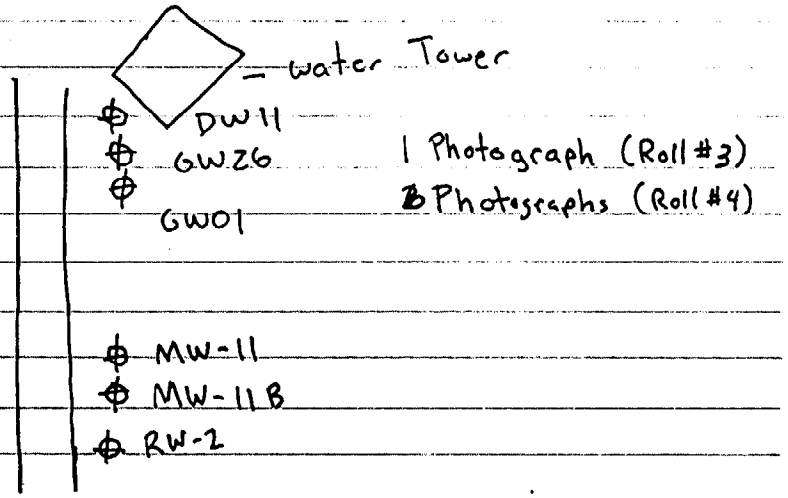
(Site 73) Site used for amphibious training and amphibious vehicle staging area. Site has remained a training area. A construction project is slated for the area immediately west of the site in areas where investigations have occurred. No significant changes have been noted recently. work is continuing at site. Two to three weeks ago several temporary well locations were installed immediately adjacent to building A-47.

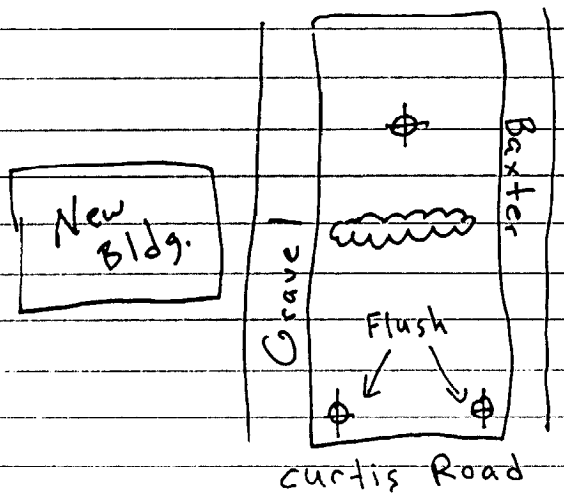
- OU No. 6, Site 44: Fencing around site in need of repair or complete removal.
- OU No. 14, Site 69: Fence around site damaged by fallen trees.

(Site 44) Fence has been breached near housing (Photo). No lock on gate leading into site. Monitoring wells remain at site. Site security is obviously not maintained.
* 2 Photographs (Roll #5)
